## The Roadster Cooling System. April 2013

## Jim Garey

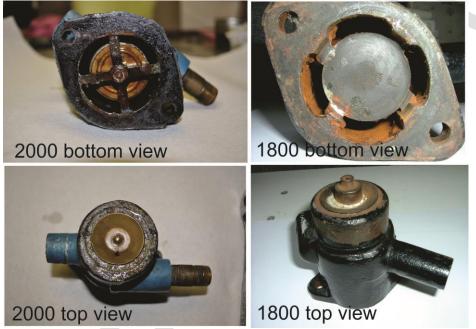
The original thermostat and housing are different in the 1800 and 2000 models and thus not interchangeable. In both types, the thermostat is an integral part of the housing and cannot easily be

separated so should be removed as a single unit for testing. New replacement originaltype thermostats are no longer available although may occasionally be found in the secondhand market.

the thermostat intact. It can be tested by placing the entire assembly in water and gradually heating the water while monitoring the temperature. It is recommended that you do not try to remove the thermostat from the housing as it needs to be correctly mounted in the housing for proper testing. The thermostat should open at a particular temperature, usually between 75 and 85 degrees Centigrade. These original thermostats are of the bypass design, so when the main valve of the thermostat is closed to prevent water from moving to the radiator, a bypass channel is opened so that water can circulate through the engine. This allows the engine to warm up more quickly and evenly, avoiding large temperature differences on the engine side of the cooling system. Conversely, when the main valve of
