Not too long ago I noticed a chunk of wood in the driveway where the roadster had been parked so I crawled under the car and found that the wood had come from the fillet piece of the wooden door frame on the right side. I inspected all the frame wood along both sides and found some deterioration along the bottom of the door rockers but none in the door risers. In my car, the door risers seem to have been made a different and more durable wood than the rest. The door hinge post and the wind screen pillars were intact and very sturdy. The fillet pieces had been cut with the grain oriented vertically so had apparently been wicking road moisture up into the wood, resulting in extremely rotten fillet pieces. The figures below show the front left door frame from the underside of the car and a paper cutout of the fillet to show where it fits in the car. There were also some issues toward the rear of each rocker, primarily cracks and voids that required some attention as well. My goal was to stabilize the wood frame components and replace the deteriorated fillets.

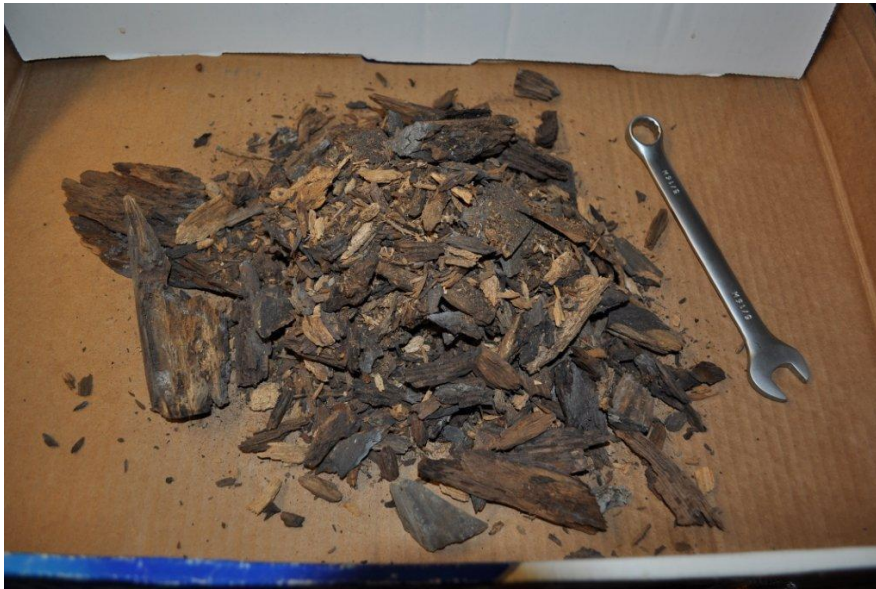
with a screwdriver and other tools removing the two rotten fillet pieces as completely as possible. I ended up with an impressive pile of wood chips and sawdust.

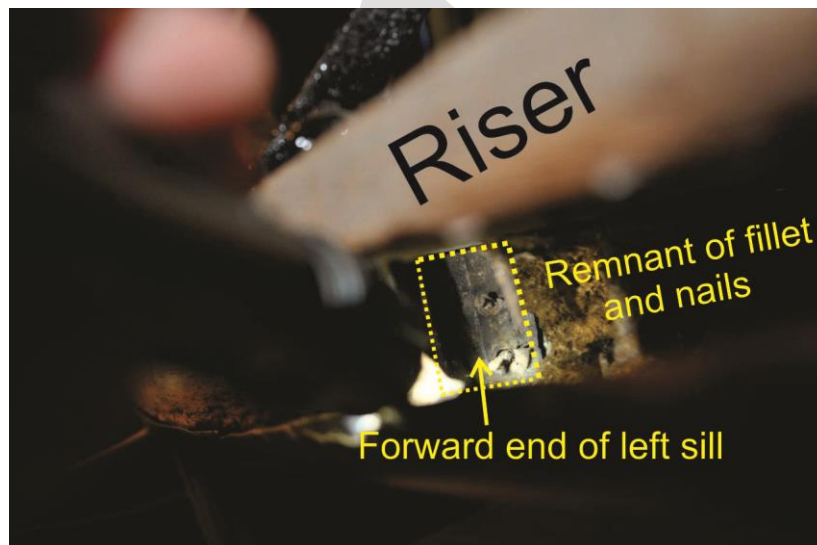
CPES is easy to apply if you have direct access to the wood, but of course it is never that simple with a roadster. If I looked into the space where the fillet pieces had been I could just see the forward end of the door sill as well as the nails that used to connect it to the fillet. The forward ends of the sills were amazingly intact where they had contacted the fillet and seemed fine.

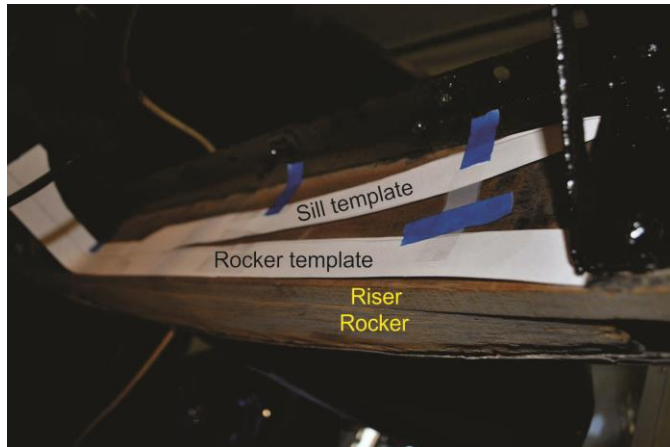
While I had the car up on stands with the floor removed I stripped the metal frame of the car with a pneumatic needle scaler to remove grease, rust and old paint and repainted it with POR 15 paint. I cleaned and sanded the wooden riser and rocker on the exposed sides so they could better absorb CPES. From Keith's drawings, I traced paper cutouts of the sill and rocker for each side. I then taped the cutouts to the door riser to visualize where they were located.

I drilled a series of $\frac{1}{4}$ inch holes angled slightly downward through the riser so they would penetrate to the center of the rocker behind the riser. I decided not to try to drill holes into the sill through the riser as the sills appeared intact even where they contacted the rotten fillet. I spaced the holes into the riser and rocker about 5 or 6 inches apart. Toward the rear I had to drill through a part of the metal frame to get into the rocker. The purpose of the holes was to have a way of getting the CPES into the interior of the rocker as recommended by the CPES supplier. I also drilled some vertical holes down into the riser to allow CPES entry into the interior of the riser. I supported the car on four wooden blocks placed under the brake drums so the frame would be in its natural position instead of on stands that support the frame.

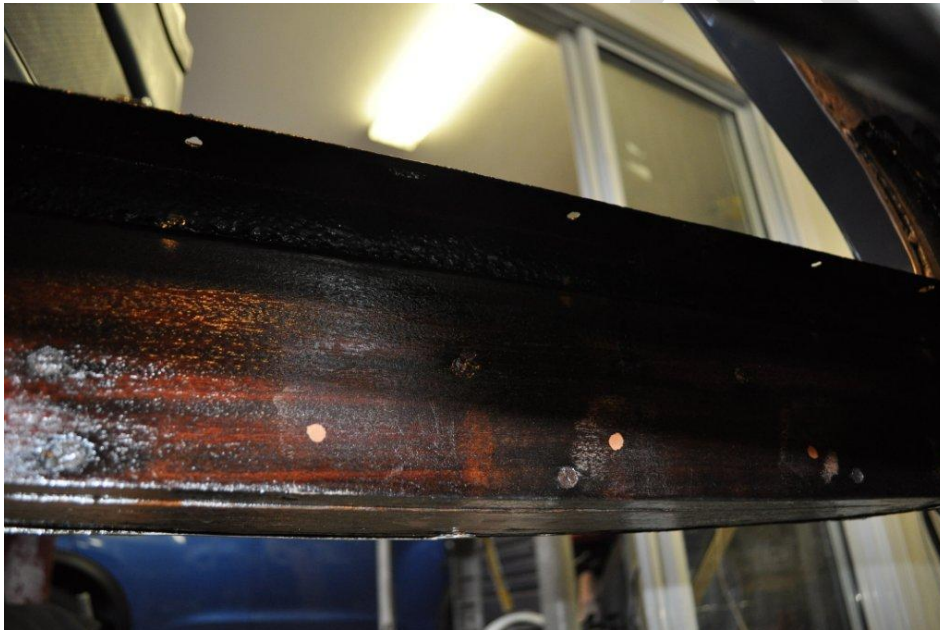
The best way to do this is to apply the CPES repeatedly to maximize the amount that can soak into the wood. I worked the left side of the car, then switched to the right side, and back and forth until the CPES set. This took several hours, used several liters of CPES and was very messy. My shirt sleeves and much of the garage floor were soaked by the CPES. I probably applied CPES at least ten times to each part of the frame in that time period. It soaked into the wood very quickly. Of course I was essentially wallowing in the CPES when I was under the car as excess constantly dripped down. I had the garage door open and several fans blowing air out of the garage, but still the respirator was essential. After a few days I mixed up some epoxy filler from the same company to patch over the holes I had drilled and to fill in some cracks and voids toward the rear of the sill. Ordinarily, applying epoxy filler to wood does more damage than good, but since the wood had been treated with the CPES, I think the filler will work well as it is designed to bond to CPES treated wood. The filled holes in the riser can be seen in the photo below. You can also see how the CPES leaves a plastic-like sheen, almost like a varnish, except that it soaks into the wood and doesn't just coat the surface.

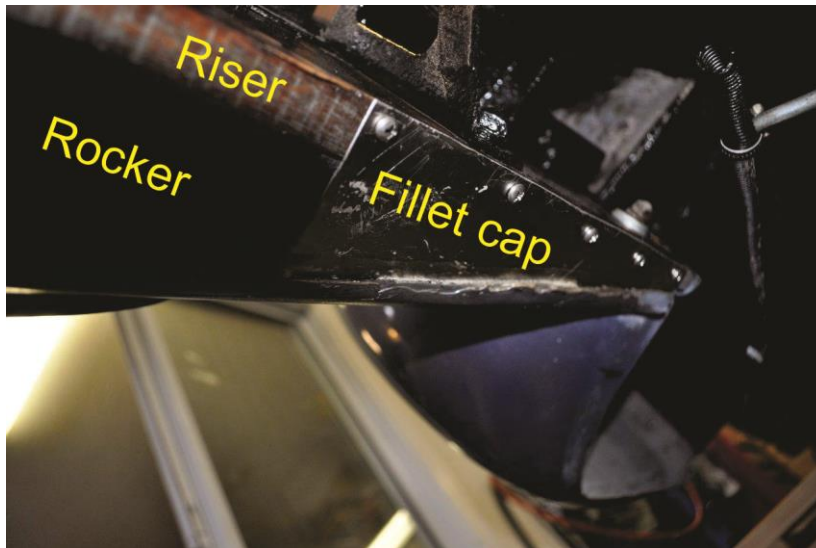
special 3M pillar foam cartridges. I made an aluminum bottom cap for each side of the car flush with the bottom of the sill so the foam would stay in the fillet void. I attached a mixing tip to the applicator and a foot of tubing to the mixing tip. Then I applied the foam into the void through a gap on the front side along the metal frame. The foam expands and I used an entire tube for each side. The process only took a few minutes and appeared to fill the entire void. A few days later I trimmed off some excess foam that had extruded out of several gaps, and then sealed the cut edges with some thick epoxy resin. This should prevent road water from wicking up into the foam cells that were cut.
